Characterization of Flow-Induced Surface Defects in Injection Moulded Components – Case Studies

ABSTRACT

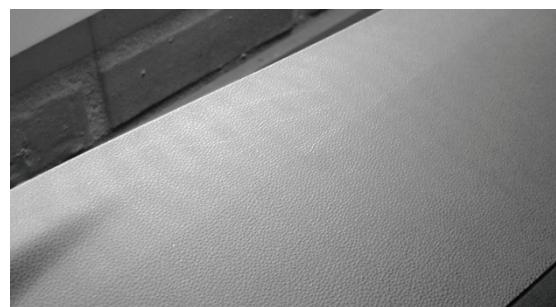
An automotive tunnel console (interior part) injection moulded in a PP-based material was evaluated with regard to its visual appearance. The surface exposed towards the driver was textured (Fig. 3), whereas the non-exposed surface had a glossier and smooth appearance. This component exhibited clear tiger stripes, especially on the non-exposed, non-textured surface.

Figure 3. Detail of an automotive tunnel console exhibiting tiger stripes on the textured surface.

The gloss levels of the dull and the glossy areas (on the non-exposed backside) were 9.8 and 12.2 GU, respectively. These results are average values based on fourteen individual measurements on different bands along the console and the standard deviation

was 0.6 GU for dull bands and 1.3 GU for glossy areas. The difference in gloss between the bands was readily visible and can be considered as large. The magnitude of the gloss difference (2.4 GU) is also in good agreement (although on the high side) with that reported by Hirano et al.⁹ for injection-moulded plaques of elastomer-modified PP. The dull bands also exhibited a lighter appearance than the glossy ones.

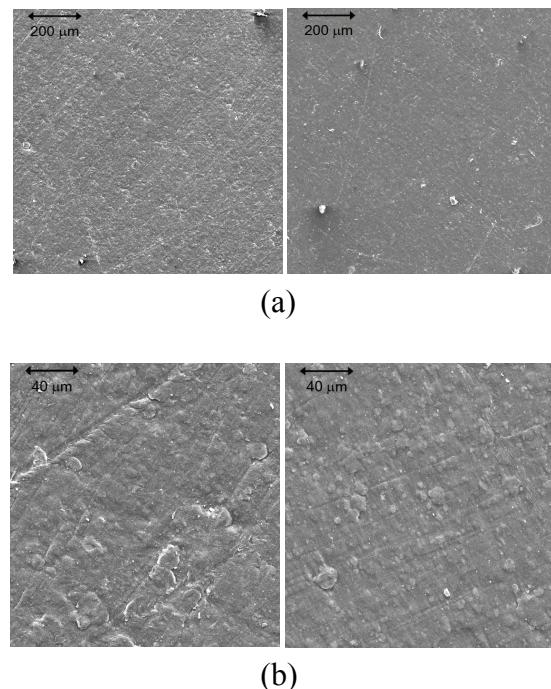
The surface of the non-exposed side of the tunnel console was investigated by SEM. Micrographs of samples from both the dull and the glossy bands were captured at magnifications from 50x to 2000x. Fig. 4 shows some representative micrographs of the two bands. At magnifications between 100x and 500x the difference in their surface appearance/roughness was quite clear. The glossy bands were visibly flatter than the dull ones, which is to be expected^{7,11}. At magnifications lower than 100x and higher than 500x, the surfaces appeared to be quite similar, i.e. any difference in surface roughness could not be discerned.

A car bumper exhibiting tiger stripes and the tunnel console mentioned before were also analyzed using the stereo-pair technique described in the Experimental section. A comparison between the dull and glossy bands of the car bumper showed that at 100x magnification the S_q -value of the dull bands ($S_q=59 \mu\text{m}$) was about 20 % larger than that of the glossy bands ($S_q=47 \mu\text{m}$). A similar difference was observed also at a higher magnification (1000x); the dull areas having a S_q -value of 6.4 μm , whereas the corresponding value for the glossy regions was 4.8 μm . (A higher magnification in effect filters surface features of greater lateral dimensions, thus

giving a lower value of the surface roughness.) The surface roughness of the dull and glossy areas of the tunnel console exhibited qualitatively a similar difference.

Figure 4. Scanning electron micrographs of the banded regions of the tunnel console: a) dull and glossy band 100x respectively; b) dull and glossy band 500x respectively.

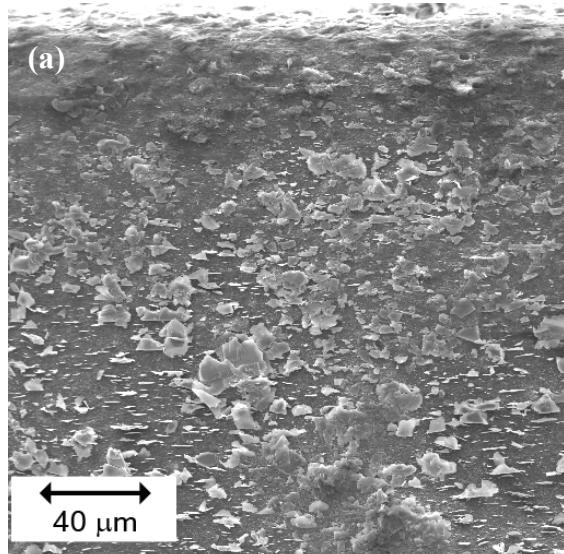
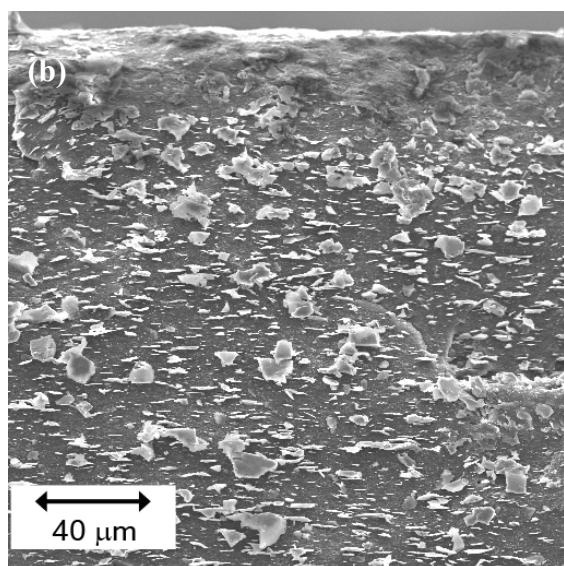
Fig. 5 provides a typical illustration of the general observation. There was in most cases a noticeable difference in filler distribution between the dull and glossy bands. The figure includes two SEM micrographs at 500x of etched cross-sections from the tunnel console; in the light bands (dull bands) the concentration of filler

Figure 5. Scanning electron micrographs (500x) of etched cross-sections of the banded regions where a) dull band and b) glossy band.

particles in the surface region was lower than in the glossy bands. No clear evidence of elastomeric particles could be discerned, probably due to its low content.

As shown in Fig. 5, it is clear that, in the inspected samples, the filler content close to the surface of the dull bands was lower than in the glossy bands, likely due to a difference in deformation/stress field in the surface regions. This may be associated with a possible stick-slip phenomenon or a difference in deformation history associated with an instable flow front. The course of events is in the following depicted in terms of slippage, but a wiggling motion of the flow front could lead to a similar result. As a starting point, it may be assumed that the dull regions corresponds to a sticking to the wall of the mould (or less deformation of the surface regions due to an upward motion of the wiggling flow front) As mentioned earlier, the surface regions will always contain less filler than the interior of the flow channel during the flow¹⁷.

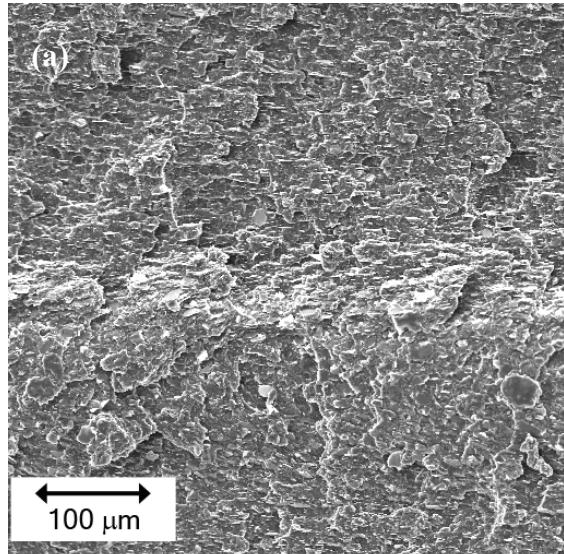
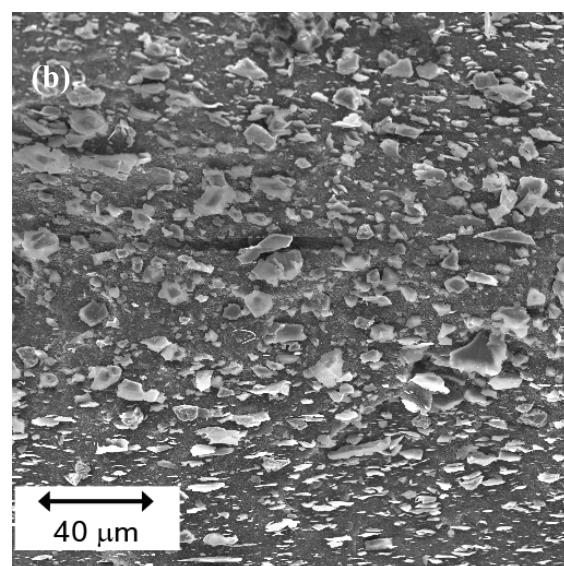
Figure 6. Scanning electron micrographs of the central area of an injection moulded tunnel console where a) is not etched sample 200x and b) etched sample 500x.

moulded components studied here (see Fig. 6). A higher particle concentration could be observed in the central areas of the specimens. The flaky particles also appeared to be less oriented in the flow direction, which corresponds to the lower stress in the central part of the flow regime.

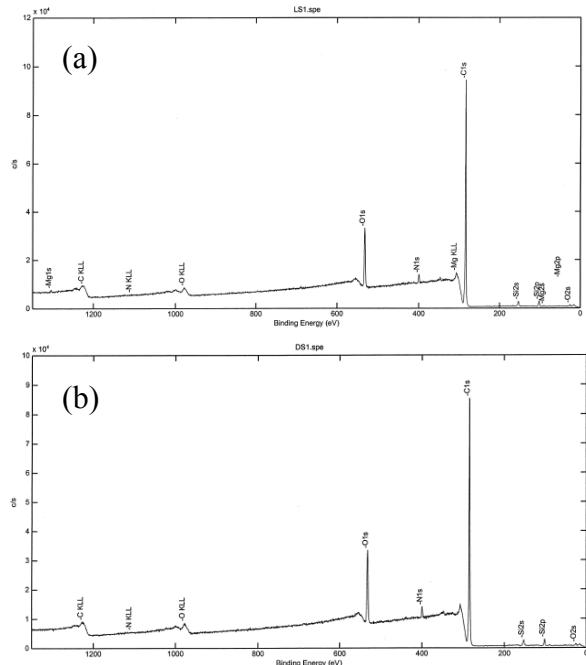
these techniques pointed to any significant differences in composition between the dull and the glossy areas of the analyzed automotive components. As an illustration, the ESCA spectra shown in Fig. 7 from the dull and glossy regions of the tunnel console samples appear to be very similar. The carbon and oxygen peaks are clearly evident, which is not unexpected, and, in both bands, some small amounts of magnesium and silicon are noted. This is likely to be associated with the talc filler.

Figure 7. ESCA spectra (binding energy, eV) from the surfaces of the dull (a) and the glossy, (b) bands of the car tunnel console.

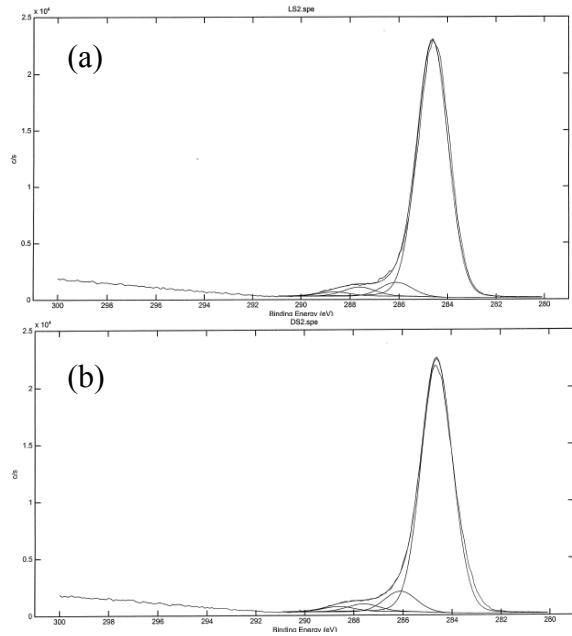
Fig. 8 shows the C(1s)-peaks separated into the components C1 – C4¹⁸ for the dull and the glossy bands. No substantial differences between the spectra can be noted, although the C2-component associated with C-O bonds were slightly more developed in case of the glossy/darker bands. This can perhaps be interpreted in terms of some oxidation of the material, but this difference is not regarded as significant.

Figure 8. ESCA spectra (C(1s)) for the dull (a) and the glossy bands, (b) of the tunnel console.
