Characterization of Flow-Induced Surface Defects in Injection Moulded Components – Case Studies

ABSTRACT

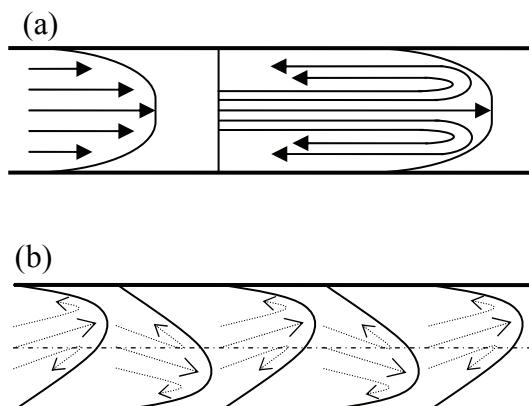
Most reports dealing with flow marks appear to associate these with a flow instability during the mould filling, i.e. a snake-like flow⁹ of the melt front giving an asymmetric fountain flow^{4,5,8,10,11} (Fig. 1).

Figure 1. a) Stable symmetric fountain flow, b) Snake-like flow due to unstable fountain flow exhibiting an oscillating stagnation point.

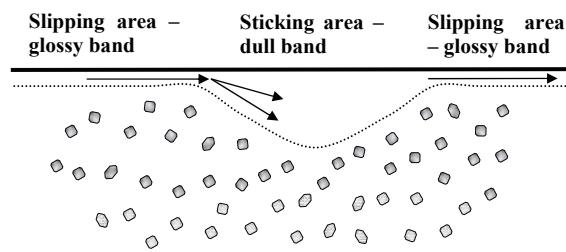
Fig. 9 schematically illustrates that when a part of the melt sticks to the mould surface, the flow or deformation, which could be of a semi-solid nature, just behind of the sticking region will tend to accumulate more of the low-filler content material in the sticking part of the melt. At the same time the slipping surface regions downstream (or deforming regions due to a downward motion of the flow front) experience a tensile deformation which gives a thinning of the low-filler content surface regions in that region. Both phenomena contribute to a thicker region of low filler content close to the surface of the parts that “sticks” to the walls of the mould cavity.

Figure 9. Schematic illustration of the possible mechanisms that govern the distribution of the filler particles in the surface regions of injection-moulded plastics showing tiger stripes.
